THE DUTCH  
SAFETY BOARD

**CRASHED DURING APPROACH, BOEING 737-800,  
NEAR AMSTERDAM SCHIPHOL AIRPORT,**  
25 February 2009

The Hague, May 2010 (project number M2009LV0225\_01)

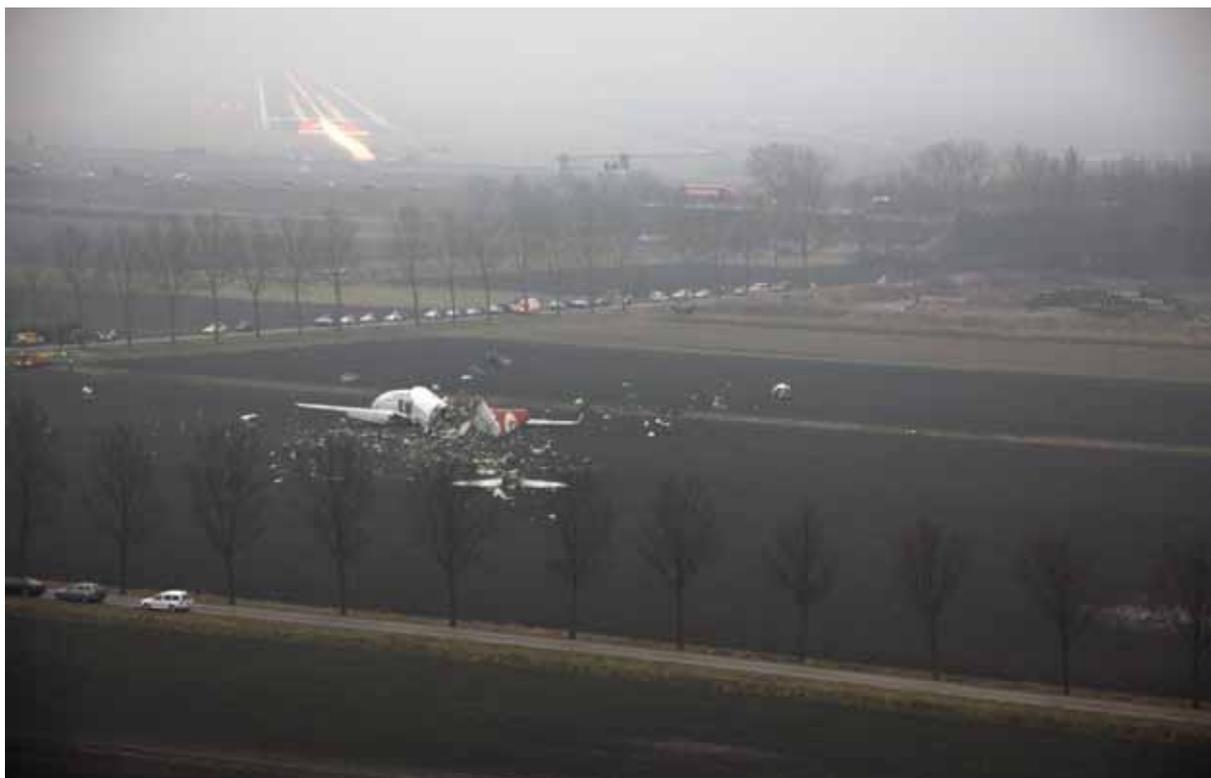
A Boeing 737-800 of Turkish Airlines made a flight from Istanbul Atatürk Airport in Turkey (LTBA) to Amsterdam Schiphol Airport (EHAM) on 25 February 2009.<sup>1</sup> The aircraft crashed while on the approach for runway 18R (the 'Polderbaan') and ended up in a field at a distance of approximately 1.5 kilometres from the runway threshold (see illustration 1). Four crew members and five passengers died and three crew members and 117 passengers were injured.<sup>2</sup>

*Illustration 1: the Boeing 737-800 that crashed with runway 18R in the background (source: KLPD)*

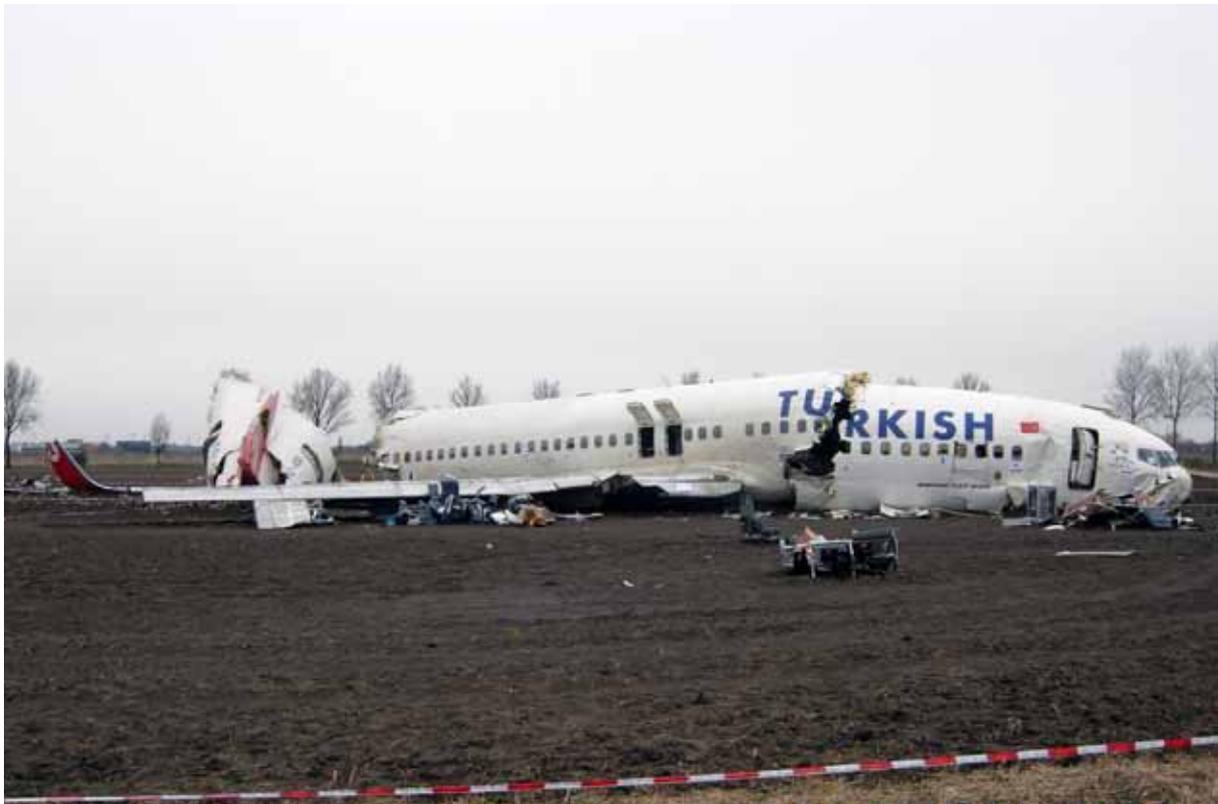
The aircraft was destroyed as a result of the impact. The fuselage of the aircraft broke into three sections; the tail section, the main section with the wings and the front section with the cockpit. The material damage to the aircraft is described in appendix K.

*Illustration 5: side view of the Boeing 737-800*

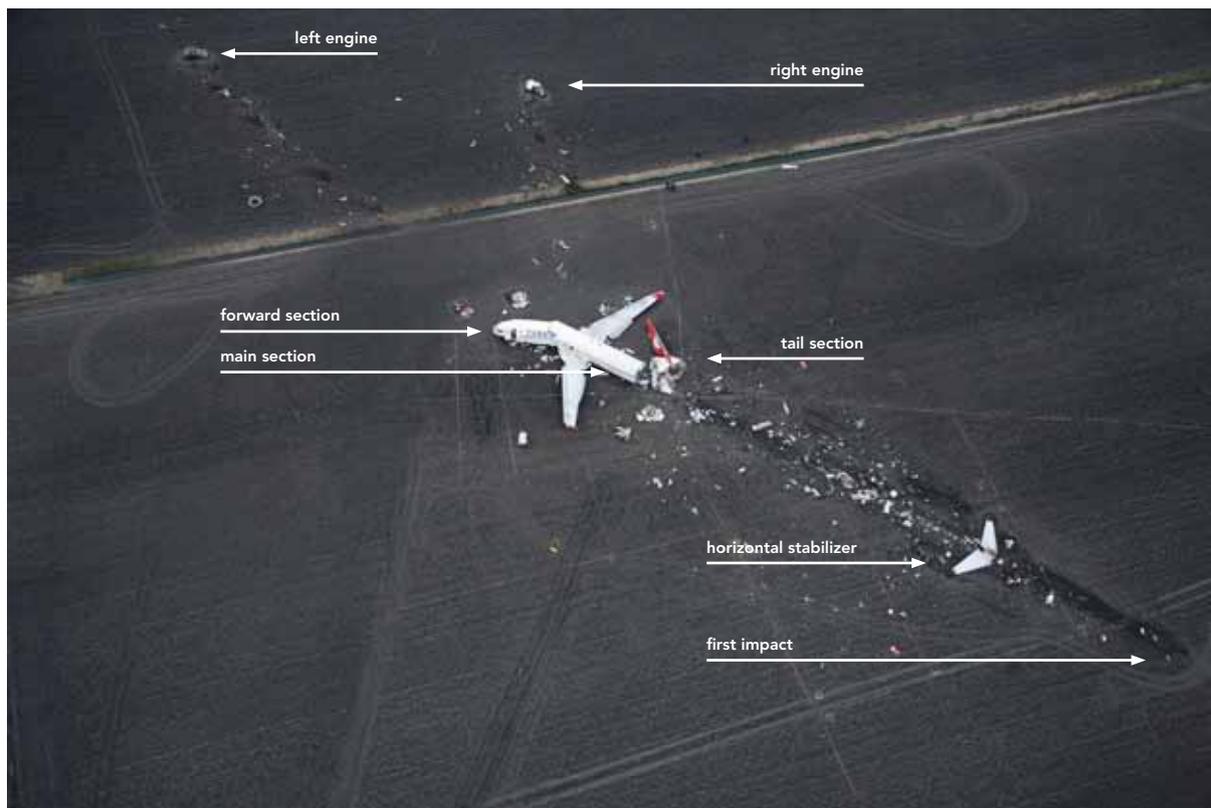
The traces of the impact revealed that the rear part of the fuselage was the first to hit the ground. The aircraft came to a standstill in a field relatively quickly due to the low forward speed that the aircraft had when impact took place. The soil conditions may possibly have had an additional braking effect.

All parts of the aircraft have been found at the location of the accident and there are no indications that something may have broken off during the flight. The flight data recorder and cockpit voice recorder data do not indicate this in any way either.

*Illustration 6: aerial photo of the aircraft that crashed (source: KLPD)*

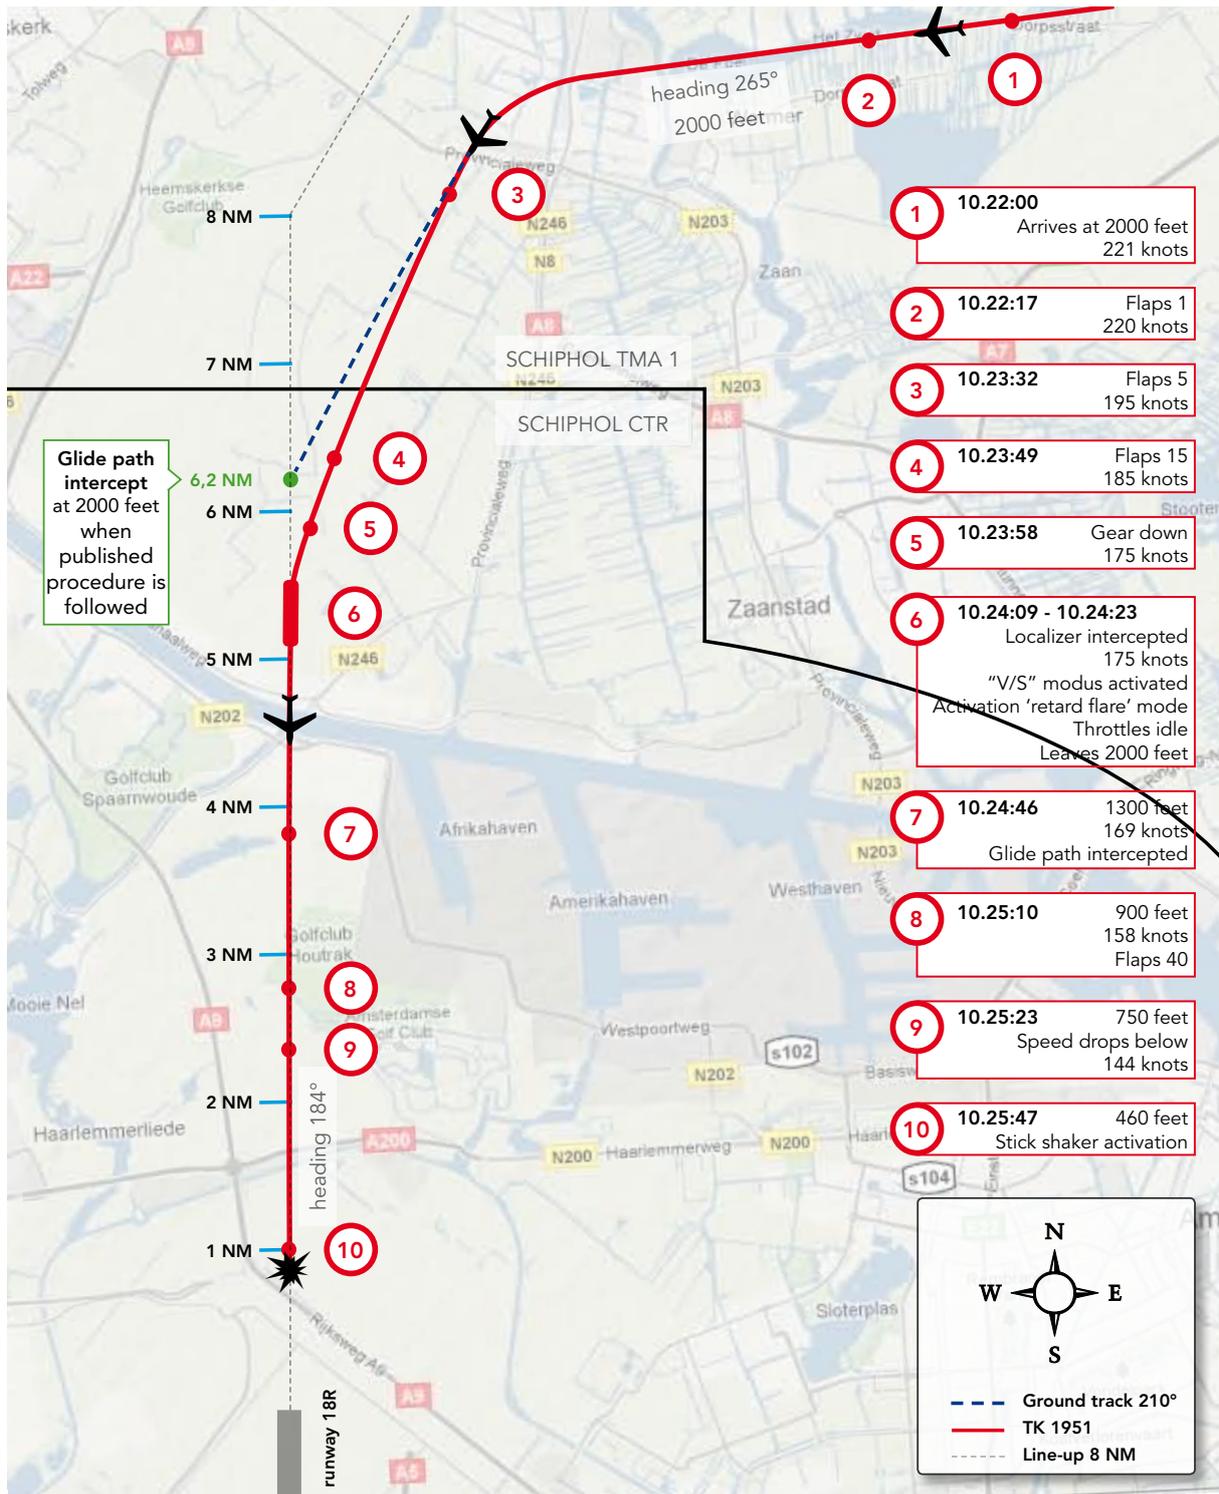
Illustration 8: top view of the ILS approach of flight TK1951 versus the intended ground track of the controller

Air Traffic Control the Netherlands has indicated that executing a turn-in manoeuvre between 5 and 8 NM for runway 18R at Schiphol airport as it occurred with regard to flight TK1951 occurs in more than 50% of all approaches for this runway. In addition, pilots sometimes ask for a short line up. LVNL is, therefore, of the opinion that aligning aircraft within the 8 NM is a normal situation. Air Traffic Control the Netherlands is also of the opinion for this same reason that aircraft crew do not have to be asked whether they can or wish to accept such a line up. Air Traffic Control the Netherlands states that air traffic controllers may broadly interpret the procedures for lining

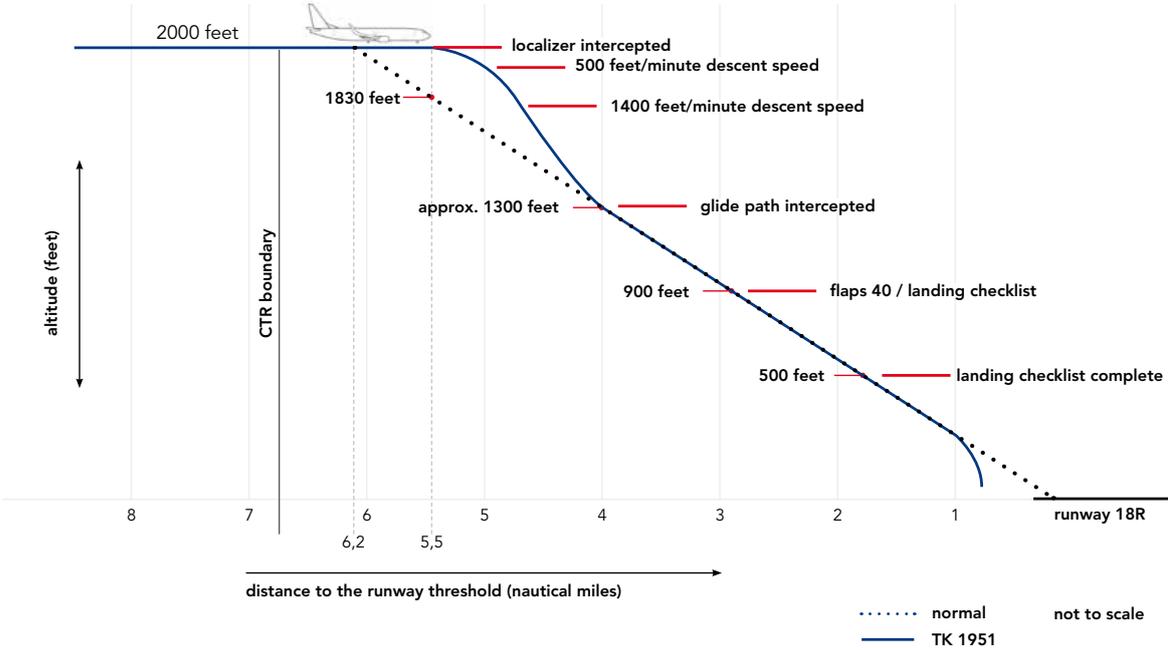
In an ILS approach the localizer and glide slope signal is normally intercepted automatically using the autopilot. The glide slope signal can normally only be intercepted after the localizer signal has been intercepted. The normal ILS procedures were not followed because the localizer signal was intercepted above the glide slope. As a result of this the glide slope signal could not be intercepted automatically. The result was that the cockpit crew had to perform a number of additional actions. The aircraft had to be put in a steeper angle of descend to obtain the required glide slope. This is shown in illustration 10 also. The actions that the crew performed in order to intercept the glide slope from above can be found in the timeline in appendix S. These actions had to be performed quickly and accurately and monitored constantly to prevent the angle of descend becoming too great to intercept the glide slope and to prevent the aircraft stopping the descend too soon to arrive at the selected altitude<sup>52</sup>. According to the cockpit voice recorder these actions were not discussed. Given the sequence and speed of these selections it is not likely that these actions were performed by the relatively inexperienced first officer, but that the captain performed these actions, which would normally be performed by the first officer as pilot flying, in addition to his own tasks. Analysis of the cockpit voice recorder, the timeline and simulator tests has confirmed this.

Illustration 10: side view of the approach of flight TK1951

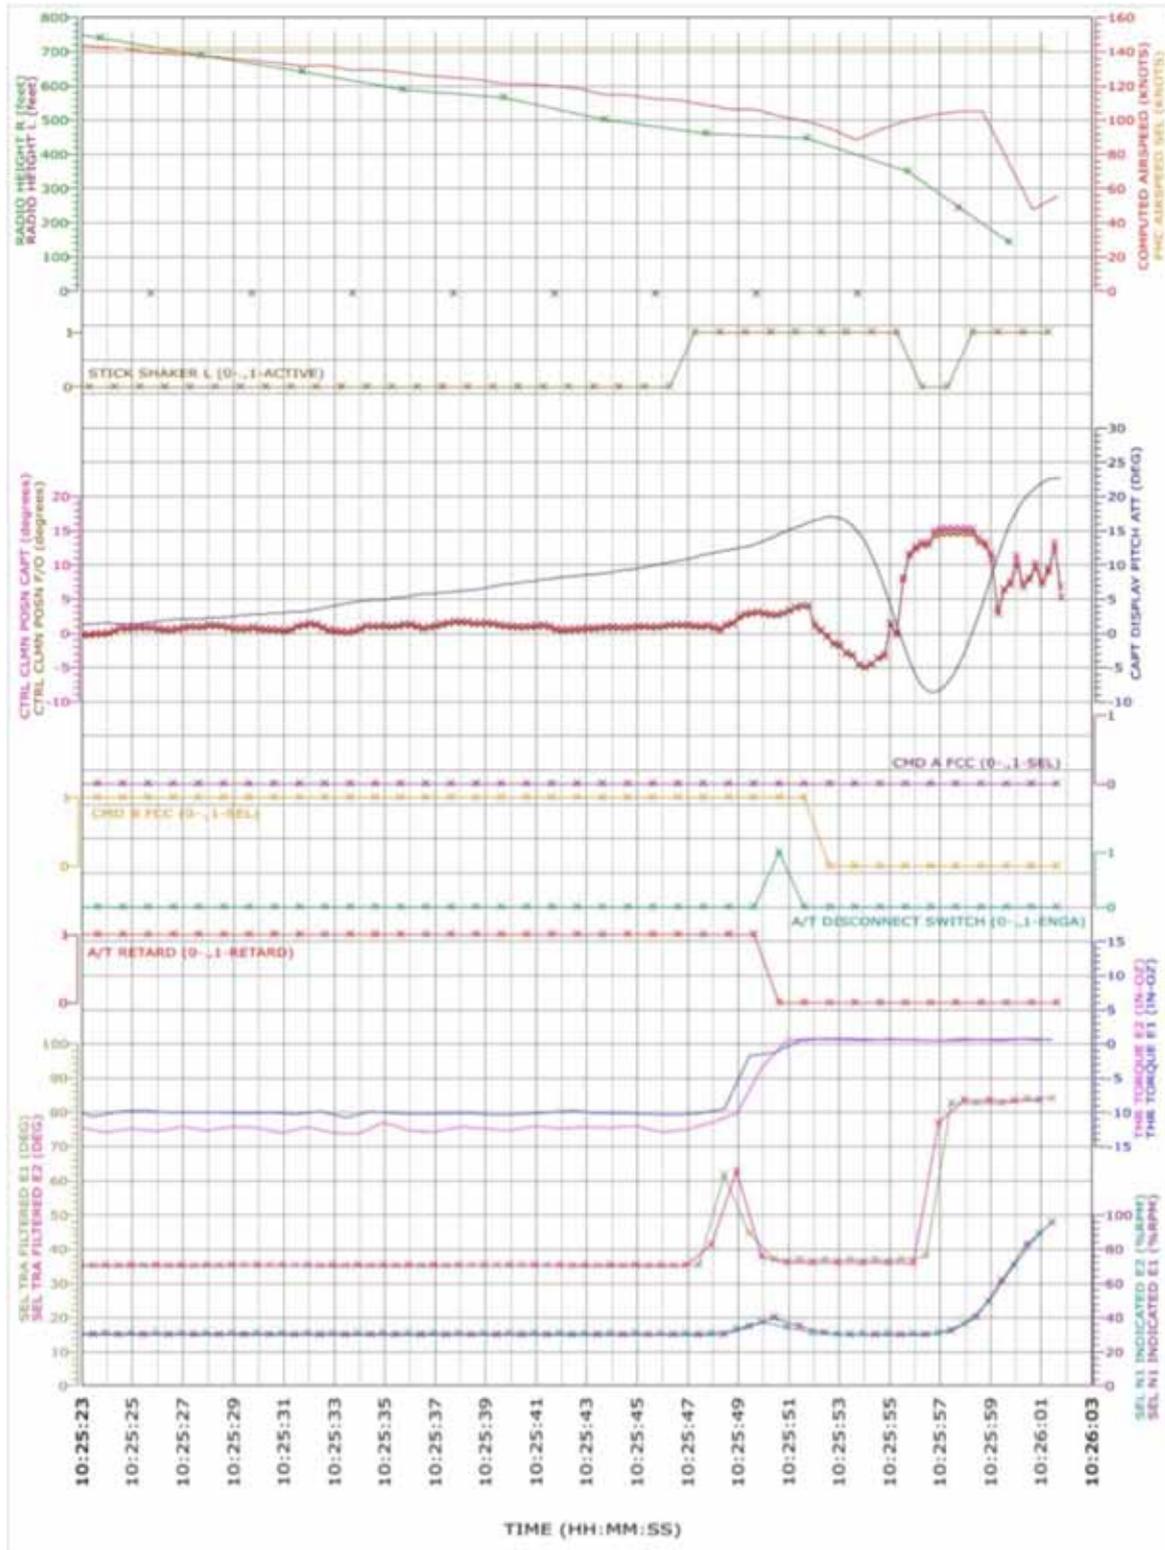
Illustration 13: parameters flight data recorder, last 40 seconds flight TK1951

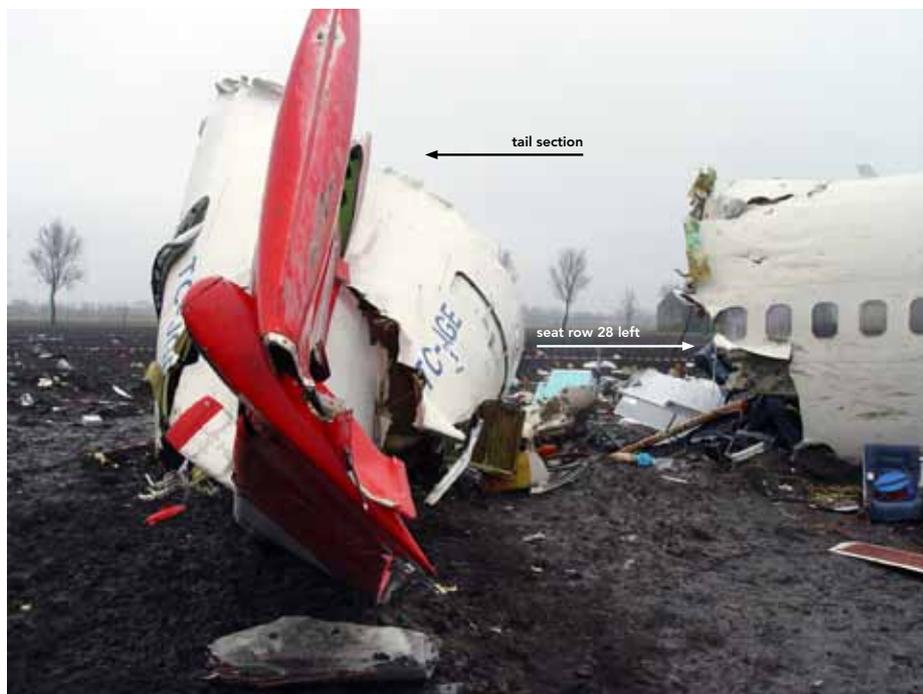
This part of the fuselage with the vertical stabiliser still attached separated in front of the rear cabin doors and sustained heavy damage. This section comprised the rear pantry and the two aft doors and was found turned 114 degrees towards the right wing. The doors of the left and right exits were partially open while the locking mechanism of both doors was still closed. Both the aft facing right and left cabin crew seats were found outside the tail section.

*Illustration 14: tail section*

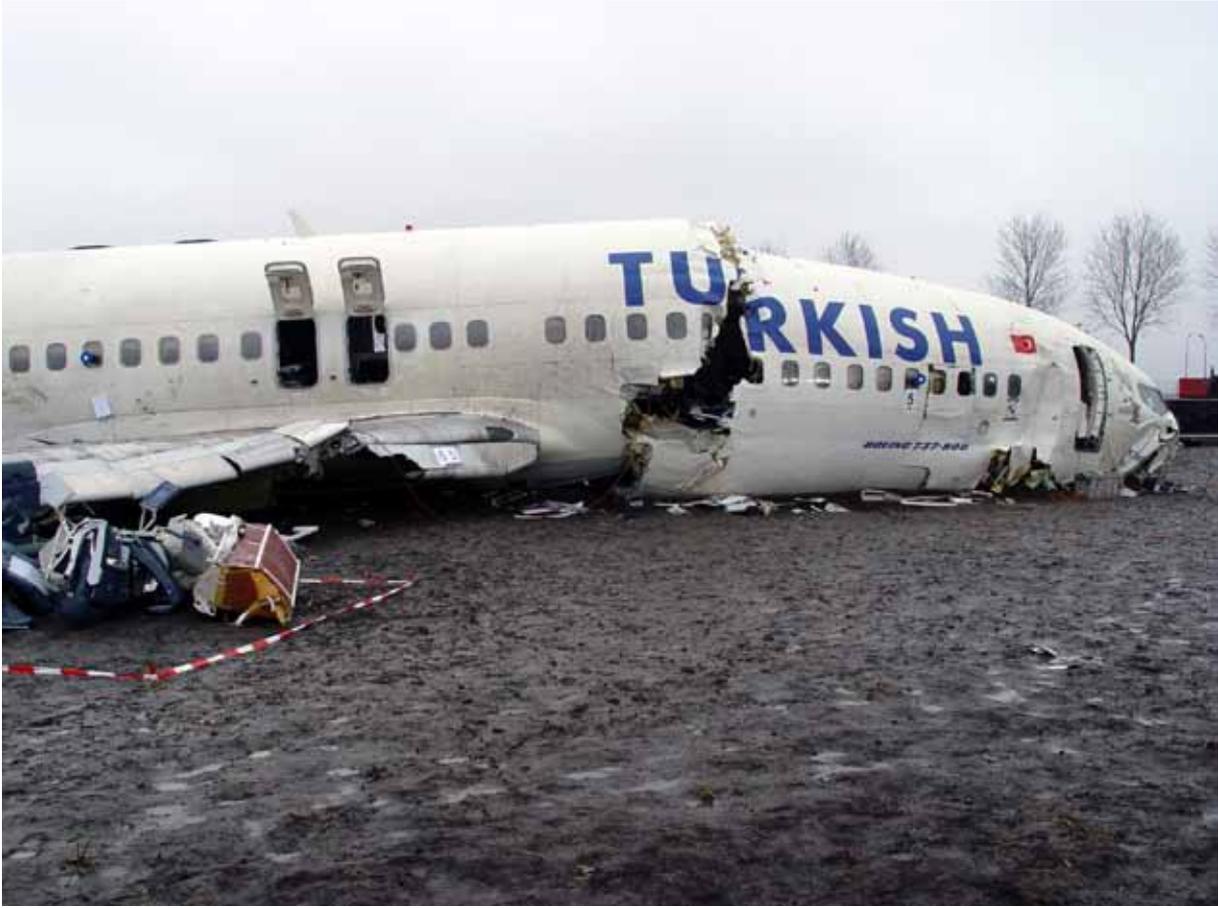
*Illustration 15: main section and front section*

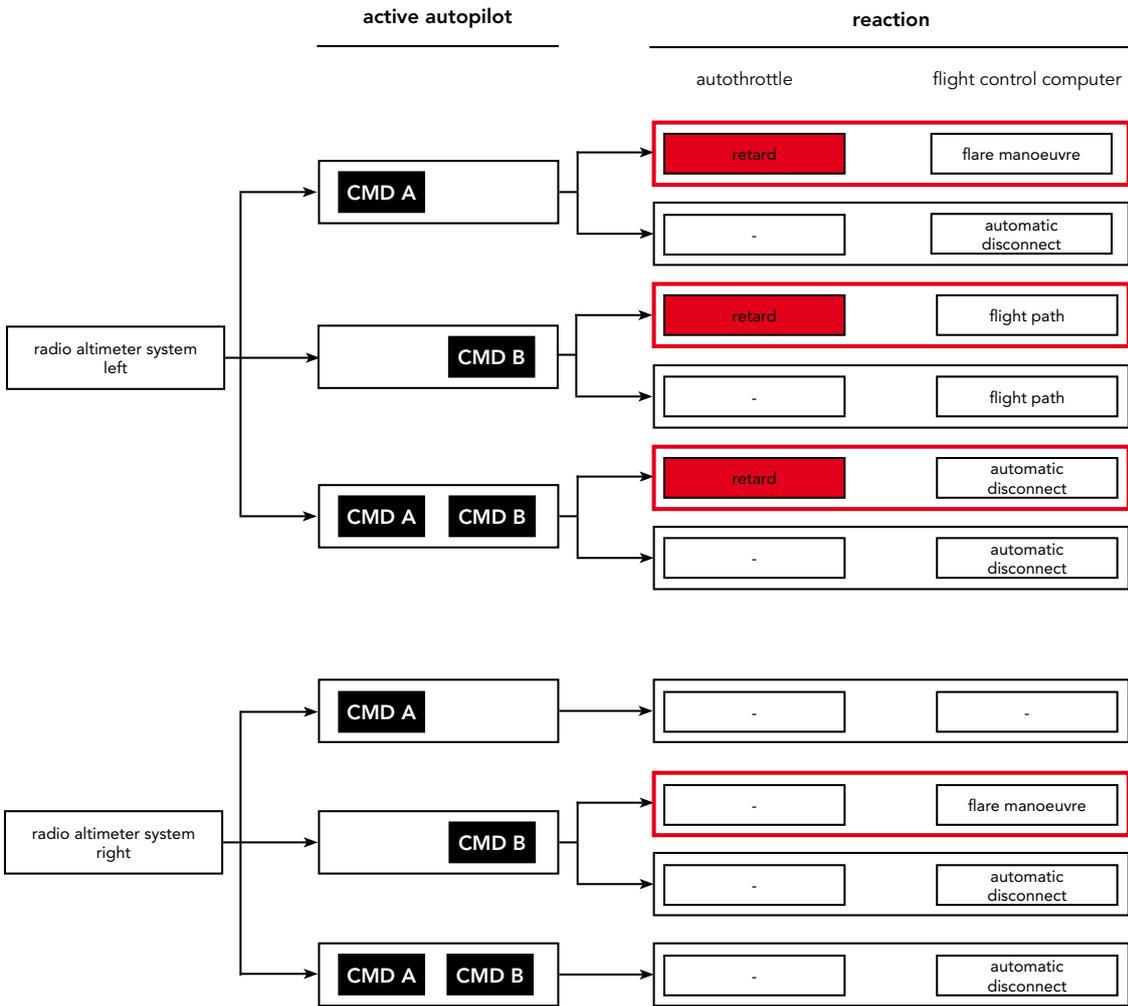
In this test, the 'retard flare' mode was activated during a 'dual channel' approach. The 'master' flight control computer activated the 'flare' command. The flight mode annunciator briefly showed 'FLARE'. The autothrottle used the 'flare' command and activated the 'retard flare' mode. The 'retard flare' mode remained active when the left-hand radio height value was less than 27 feet.

Illustration 18 shows a simplified overview of the most relevant responses to the input data for the three test configurations. Not all of the responses are included in this overview. The overview does not, for instance, include the differences between the Smiths and Collins flight control computers with radio height values characterised as 'non computed data'.

Illustration 18: simplified schematic overview of the responses of the autothrottle and flight control computer to an erroneous radio altimeter signal (<27 feet).

2. The FAA and EASA should ensure that the undesirable response of the autothrottle and flight management computer caused by incorrect radio altimeter values is evaluated and that the autothrottle and flight management computer is improved in accordance with the design specifications.
