Midair Collision Over Hudson River  
Piper PA-32R-300, N71MC  
and Eurocopter AS350BA, N401LH  
Near Hoboken, New Jersey  
August 8, 2009

**Aircraft Accident Summary Report**

NTSB/AAR-10/05  
PB2010-910405

NTSB/AAR-10/05  
PB2010-910405  
Notation 8146B  
Adopted September 14, 2010

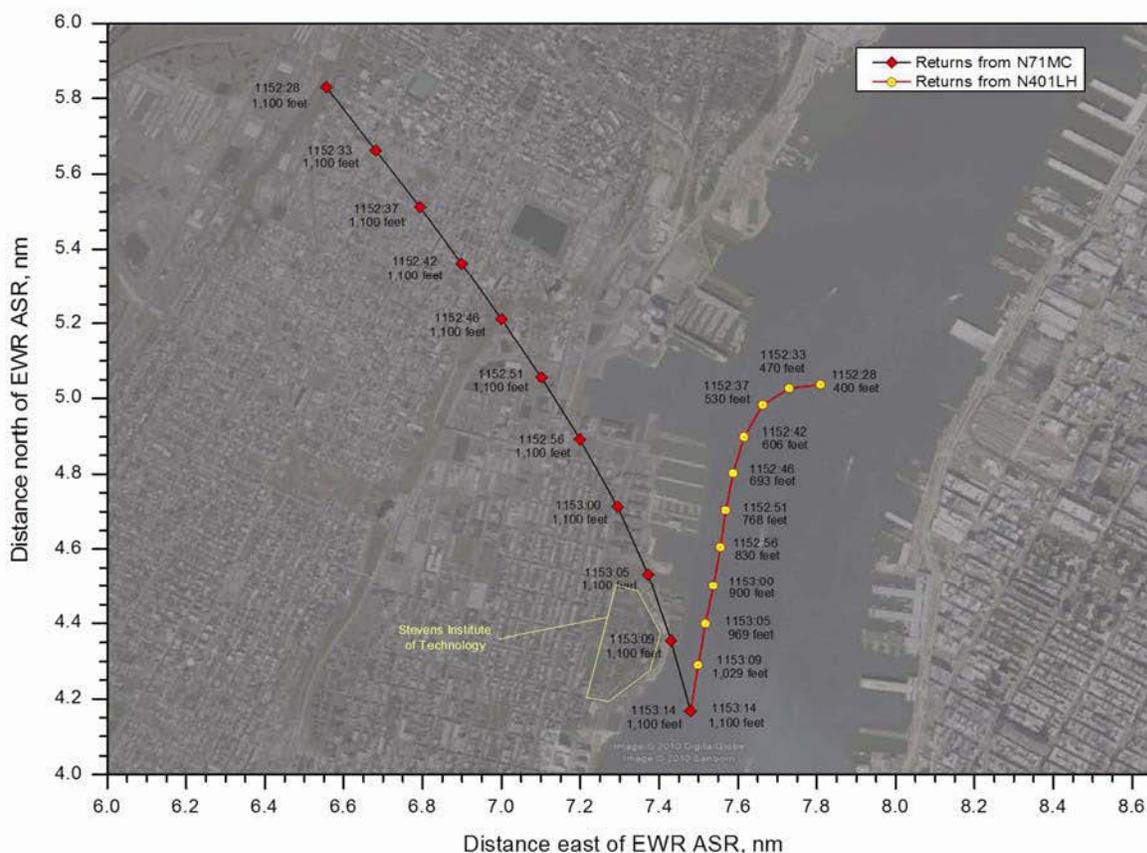
calculate the position and orientation of each aircraft in the minutes preceding the accident.<sup>22</sup> Figure 1 shows the ground tracks of the accident aircraft and the collision location over a Google Earth™ image of the Hudson River Class B exclusion area along with each aircraft's mode C-reported altitudes at each data point. This information was used to estimate the approximate location of each aircraft during the same time as viewed from the other aircraft's windscreen and the traffic information that could have been presented on the navigation display in each aircraft, as discussed in section 2.2. Figure 2 shows the Class B exclusion area in relation to the surrounding Class B airspace. The accident aircraft ground tracks just before the collision are also depicted.

**Figure 1.** Accident aircraft ground tracks.

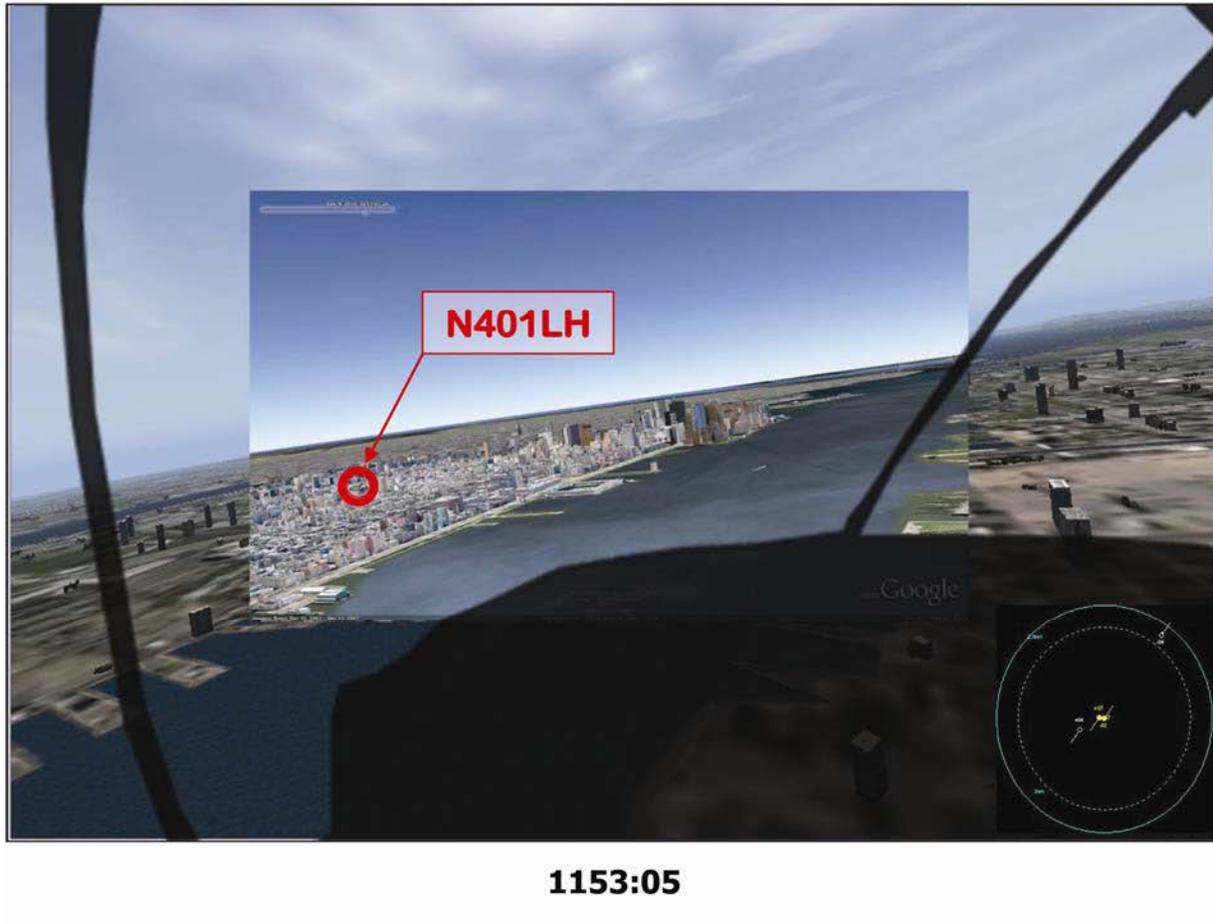
**Figure 3.** View of helicopter from airplane cockpit about 9 seconds before collision.

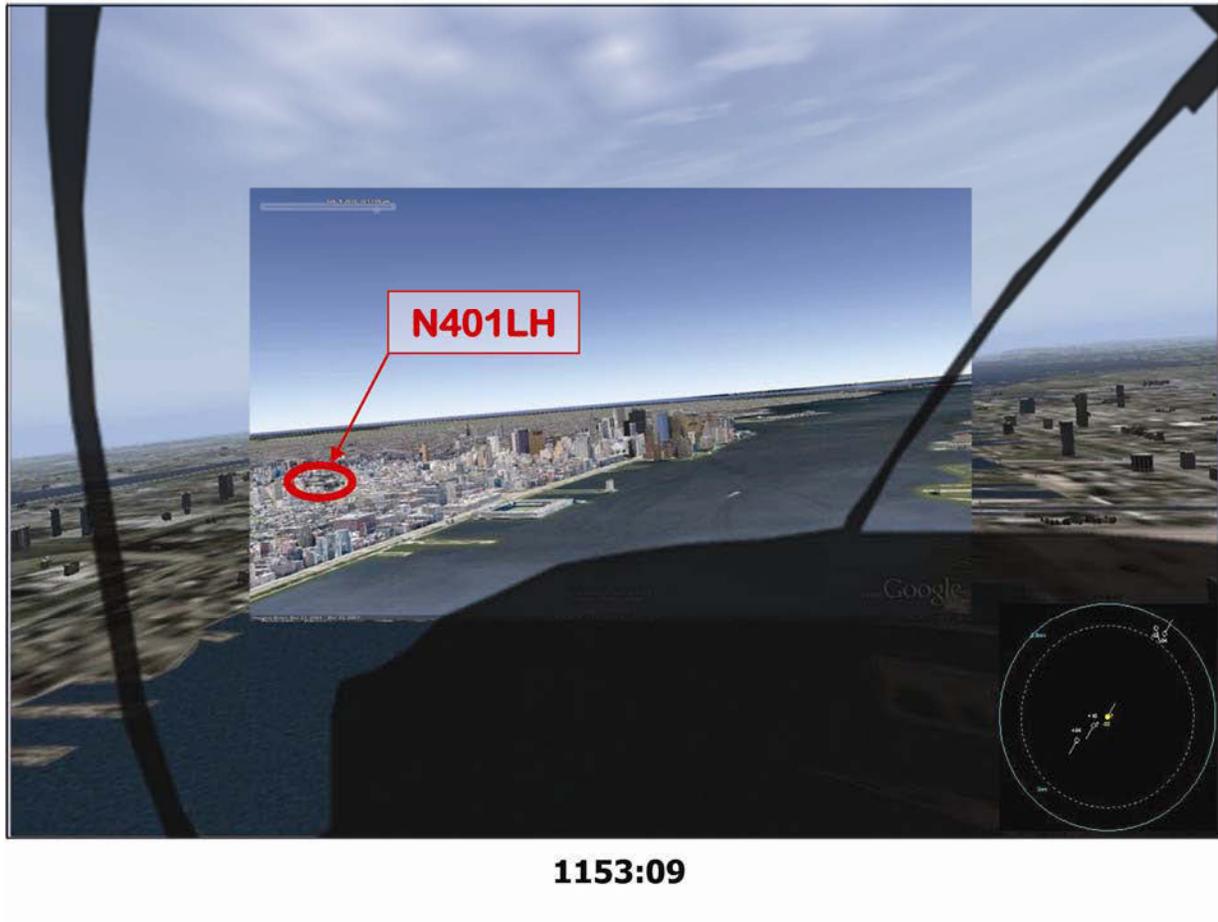
**Figure 4.** View of helicopter from airplane cockpit about 5 seconds before collision.

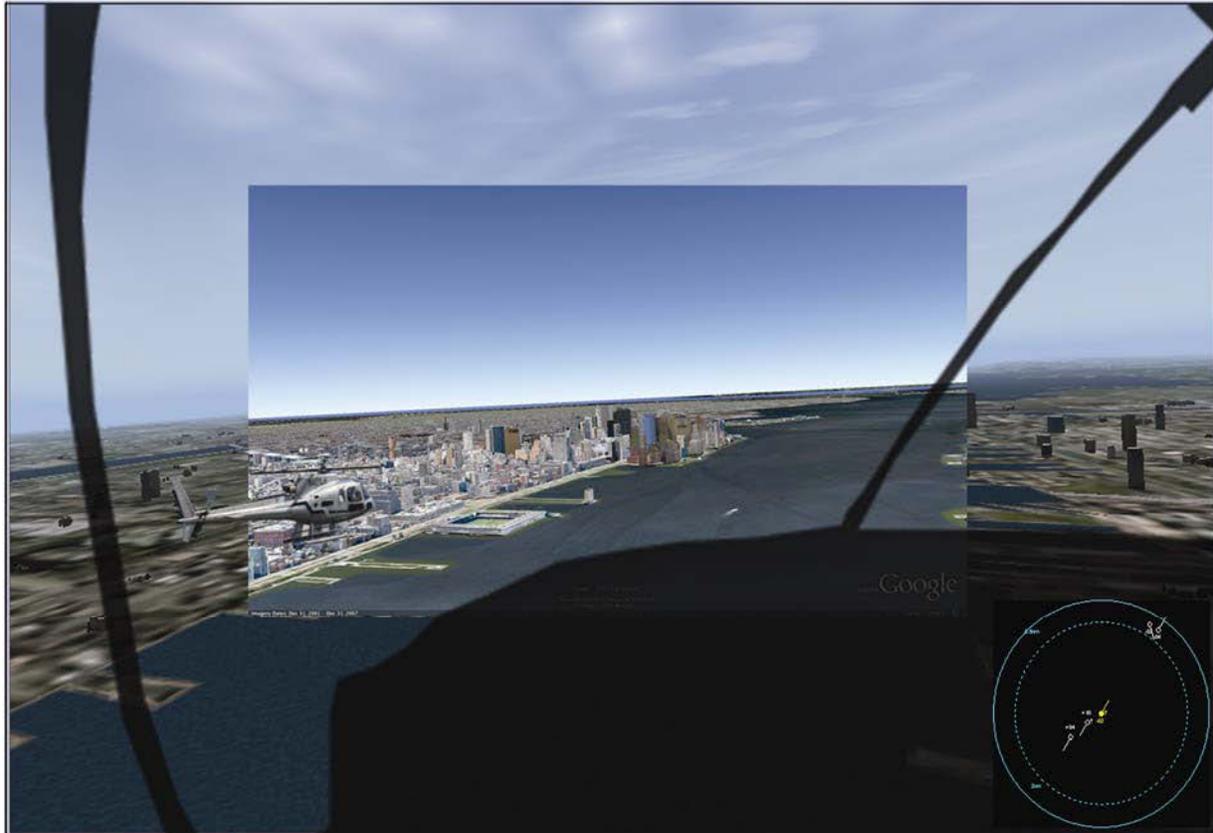
**1153:13**

**Figure 5.** View of helicopter from airplane cockpit about 1 second before collision.

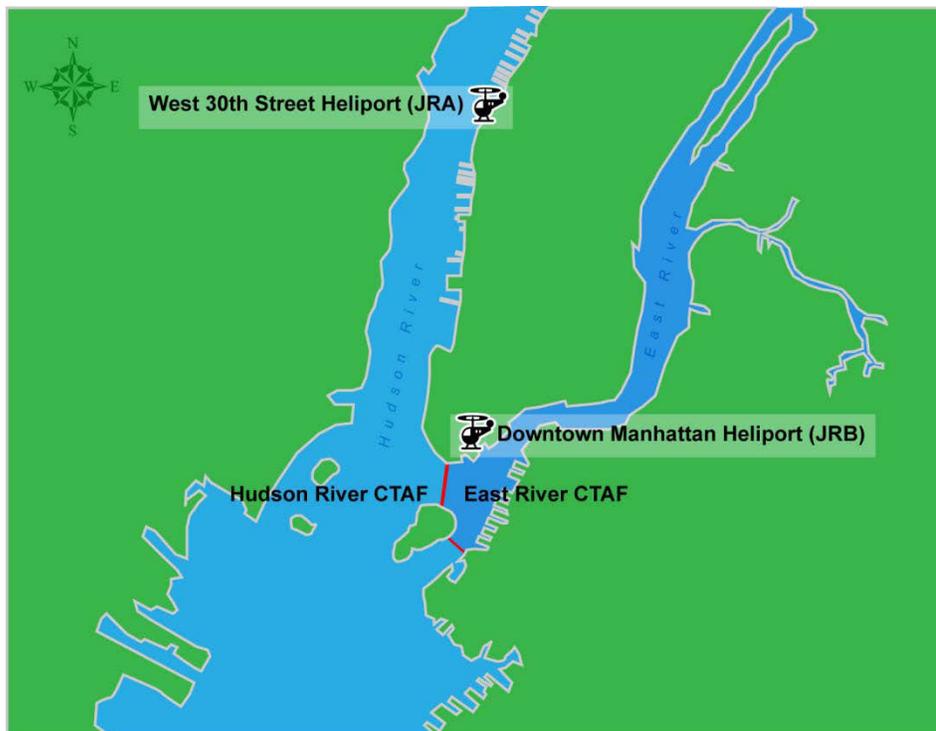
**Figure 6.** Location of West 30th Street and Downtown Manhattan Heliports and Boundary Between Hudson River and East River common traffic advisory frequencies.

The NTSB concludes that pilots operating air tour helicopters to and from JRB may not be fully aware of other aircraft operating over the Hudson River because the CTAF used for such flights is for the adjacent East River area. Therefore, the NTSB recommends that the FAA redefine the boundaries of the East River CTAF so that JRB will be located in the area that uses the Hudson River CTAF.
