Mars Climate Orbiter

Mishap Investigation Board

Phase I Report

November 10, 1999

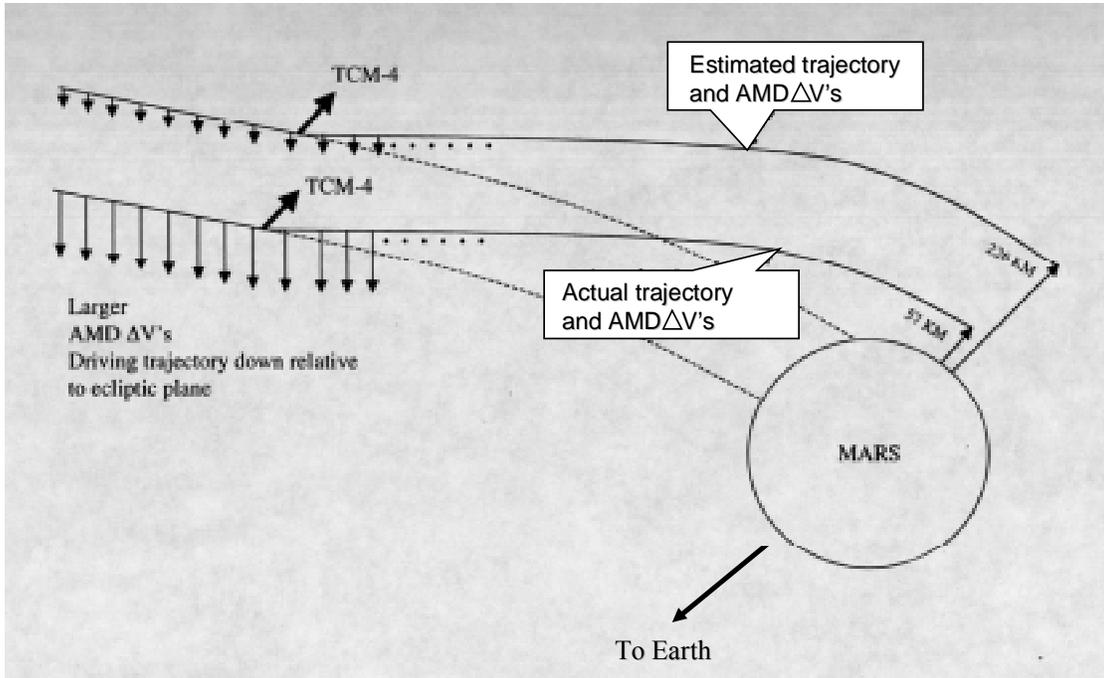
Figure 4

Finally, after the fact navigation estimates, using all available data through loss of signal, with corrected values for the small forces ΔV 's, indicated an initial periapsis (lowest point of orbit) of 57 km which was judged too low for spacecraft survival.
