W. B. COLEMAN CO.
TESTING LABORATORIES

MATERIAL: Green Residue

CHEMICAL ANALYSIS

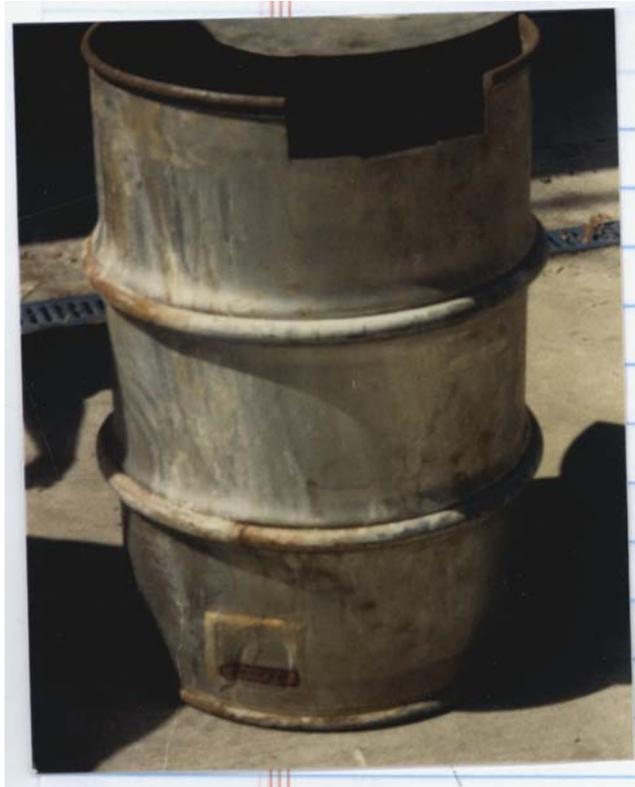
Laboratory Nos.:	992411				
Markings:	Carbon Steel Rim	Sidewall <i>Barrel</i>	Lid <i>Barrel</i>		
Graphitic Carbon					
Combined Carbon					
Total Carbon -	.057	.060	.060		
Manganese	.28	1.77	1.83		
Phosphorus	.005	.024	.028		
Sulfur	.011	.011	.030		
Silicon	.01	.51	.48		
Nickel		8.21	8.41		
Chromium		18.21	18.32		
Molybdenum		.32	.24		
Titanium					
Copper		.31	.32		
Cobalt					
Aluminum					
Vanadium

Figure 1: Analysis of barrel composition.

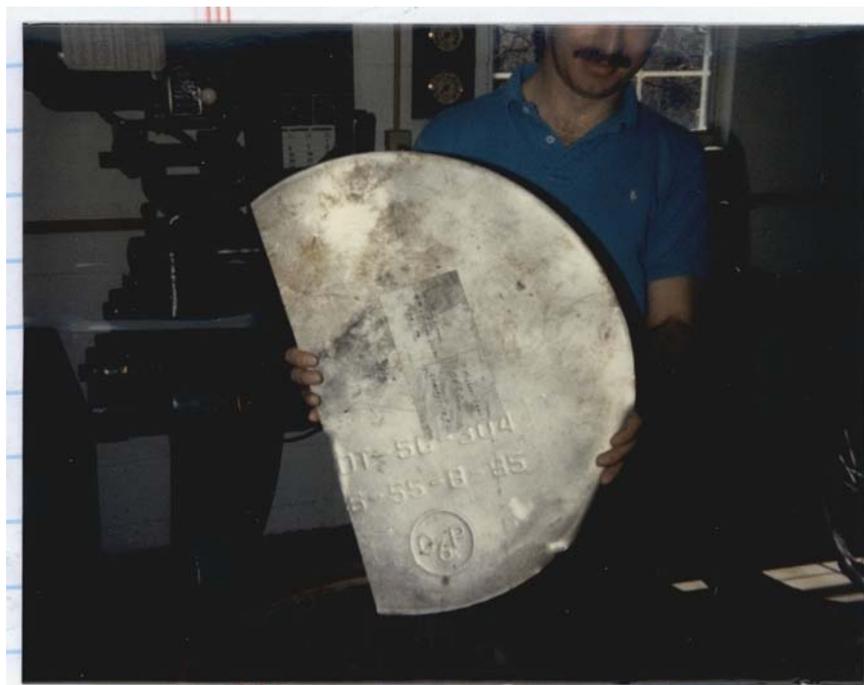
Figure 2: Barrel after failure.

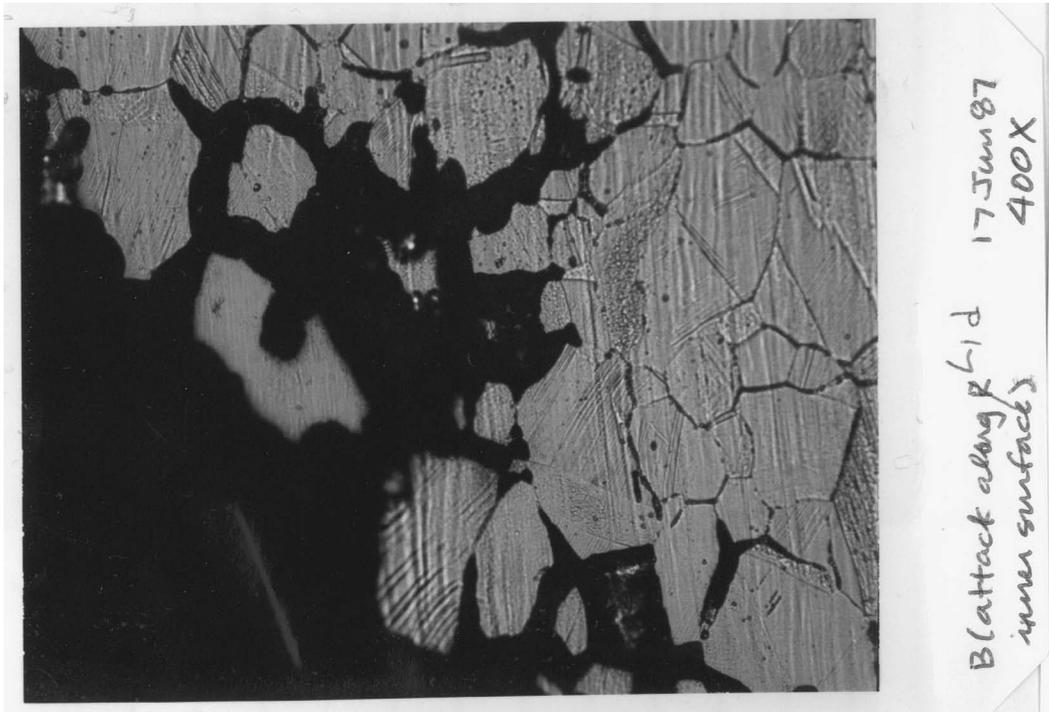
Figure 3: Corroded lid of barrel.
