THE DUTCH  
SAFETY BOARD

**CRASHED DURING APPROACH, BOEING 737-800,  
NEAR AMSTERDAM SCHIPHOL AIRPORT,**  
25 February 2009

The Hague, May 2010 (project number M2009LV0225\_01)

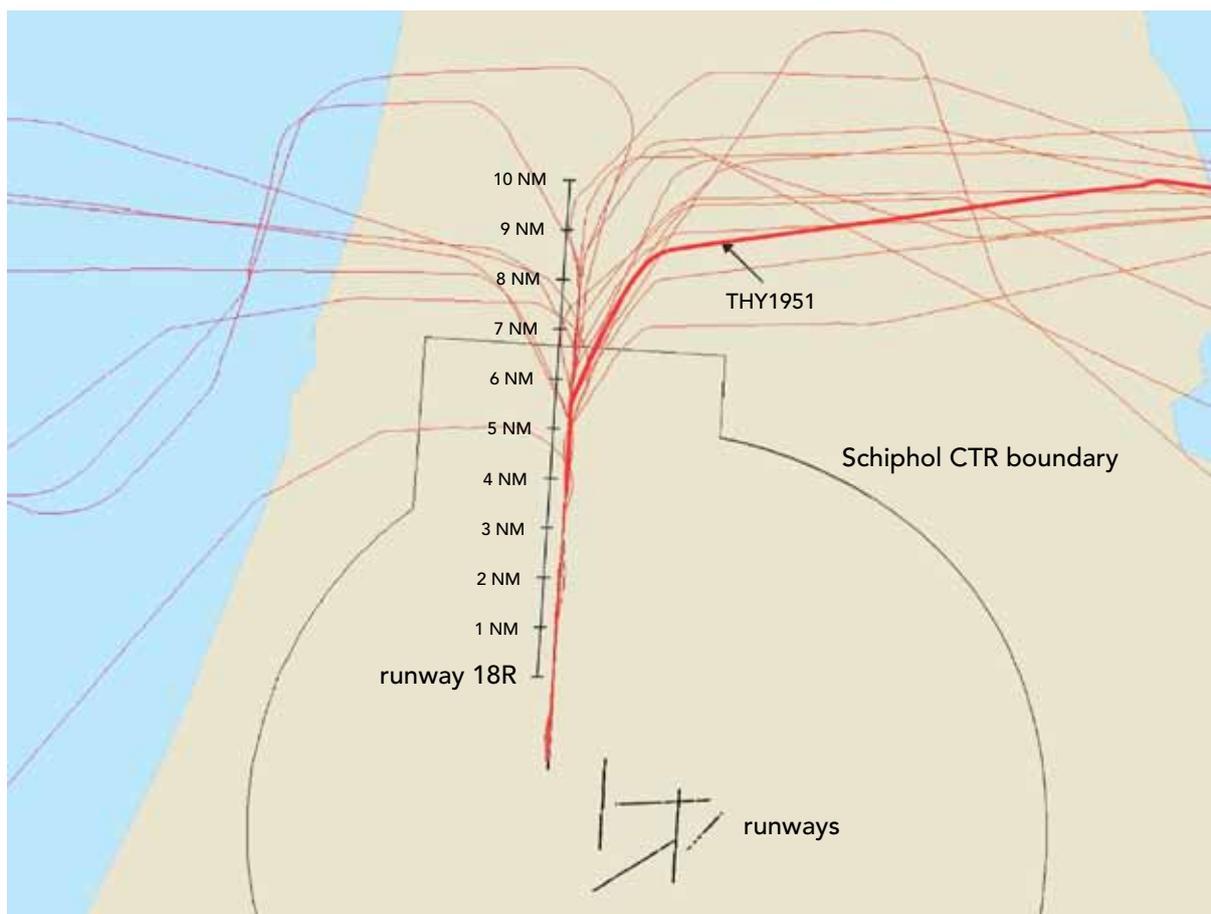
*Illustration 7: radar data air approaching traffic runway 18R, between 09.20 and 10.30 hours on 25 February 2009 (source: ATC the Netherlands)*

By giving instructions to approaching aircraft with which they are expected to intercept the localizer signal at 2000 feet just before 6.2 NM, there is no room for deviations. In this case an upper wind finally resulted in an interception of the localizer signal, approximately 1 NM more to the south than planned. When lining up at 8 NM such a deviation will not give problems.

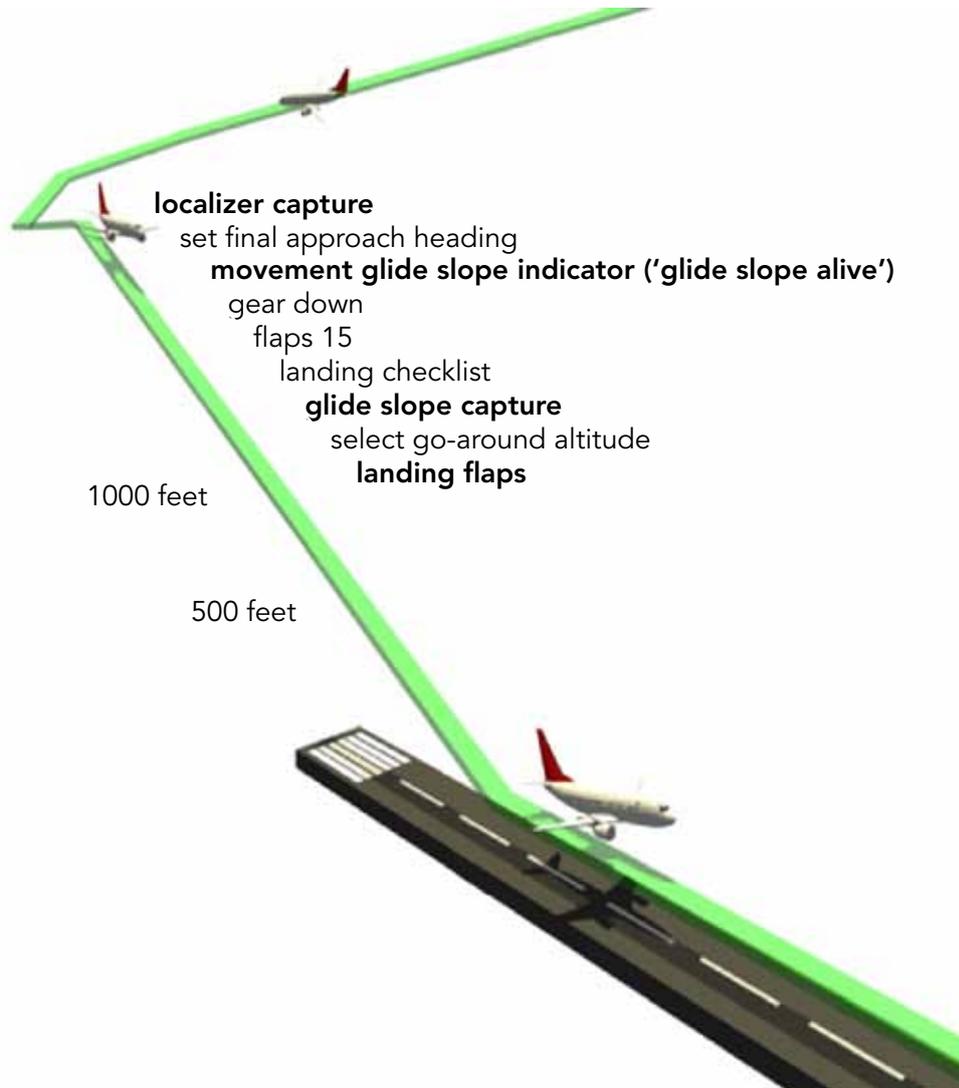
*Illustration 9: schematic depiction of Turkish Airlines procedures for an ILS approach*

During the flight the cockpit crew could see that the aircraft would intercept the localizer signal above the glide slope while flying the instructed heading 210 degrees at 2000 feet because the primary flight display specifies the position of the localizer and glide slope signals and the navigation display<sup>50</sup> shows the ground course line.

The cockpit crew started configuring the aircraft for the approach before the localizer signal had been intercepted. The landing gear was lowered and flaps 15 was selected. Normally these actions are carried out after the localizer signal has been intercepted and the glide slope indicator on the primary flight display starts to move. From this it follows that the crew were aware that the course to the ILS would place the aircraft above the glide slope. At Turkish Airlines<sup>51</sup> the landing checklist is completed for an ILS approach after the landing gear has been lowered and flaps 15 has been selected (see illustration 9 also). However, the landing checklist was completed at a later stage of the approach. The reason for this is not known. It is possible that the cockpit crew postponed it because they had to perform additional actions in connection with approaching the glide slope from above and having to monitor this constantly.

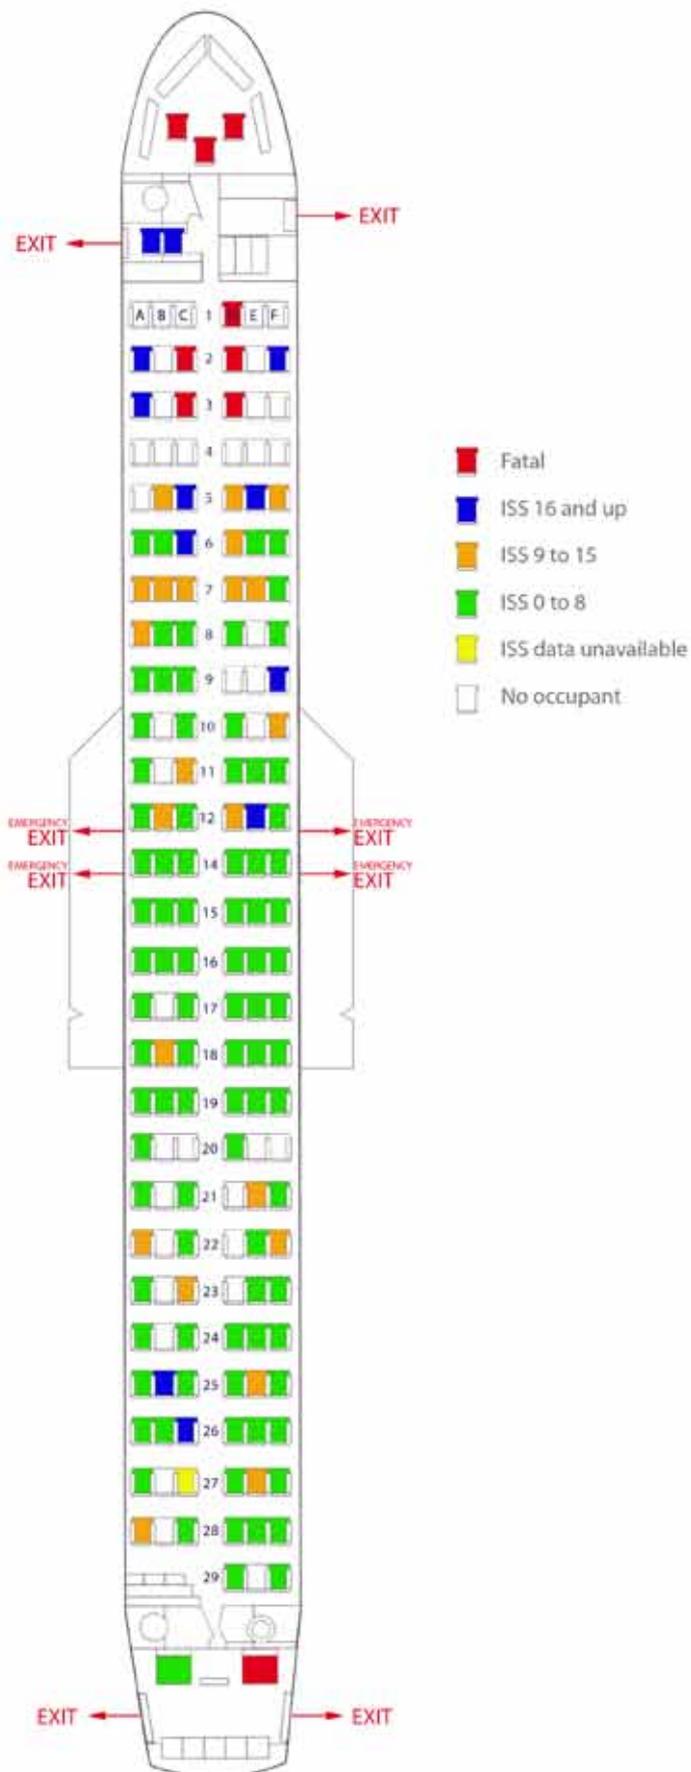
Illustration 11: gravity of injuries to occupants by seating position, according to ISS scale

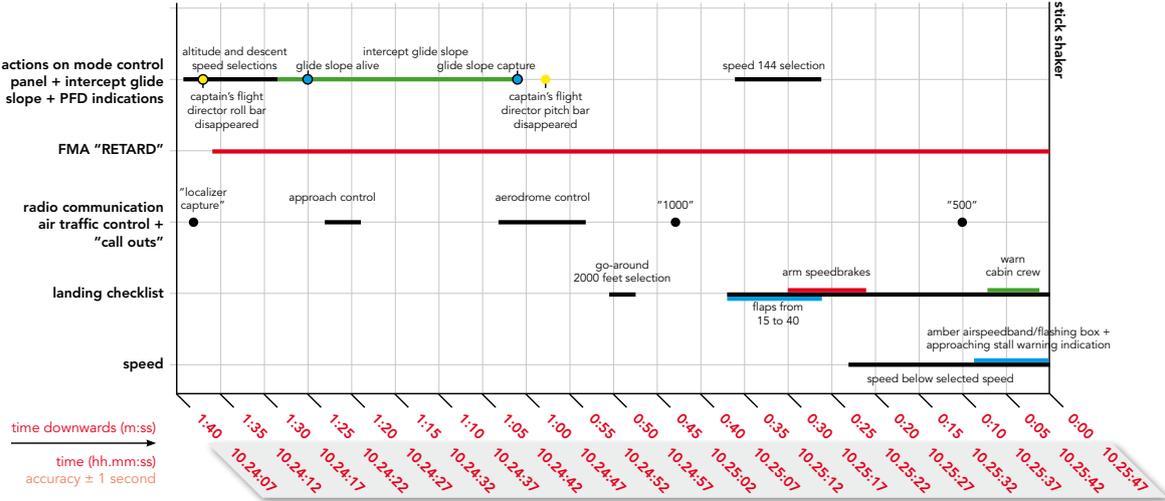
The crew must select a lower altitude<sup>118</sup> and another mode for the autopilot to ensure the aircraft descends. The flight data recorder data and the simulator tests have shown that the following actions were performed consecutively for intercepting the glide slope from above, which in total took approximately 40 seconds to accomplish (also see the timeline):

- Setting the altitude at 1100 feet to which the aircraft should descend.
- Selection of the vertical speed mode of the flight control computer.
- Setting the rate of descend to 500 feet per minute.
- Setting the rate of descend to 1400 feet per minute.
- Setting the altitude at 700 feet to which the aircraft should descend.
- Monitoring the descend of the aircraft on the rate-of-climb indicator and the interception of the glide path through the glide slope indicator on the primary flight display.

Illustration 19: timeline of actions performed by the crew between the interception of the localizer signal and the activation of the stall warning

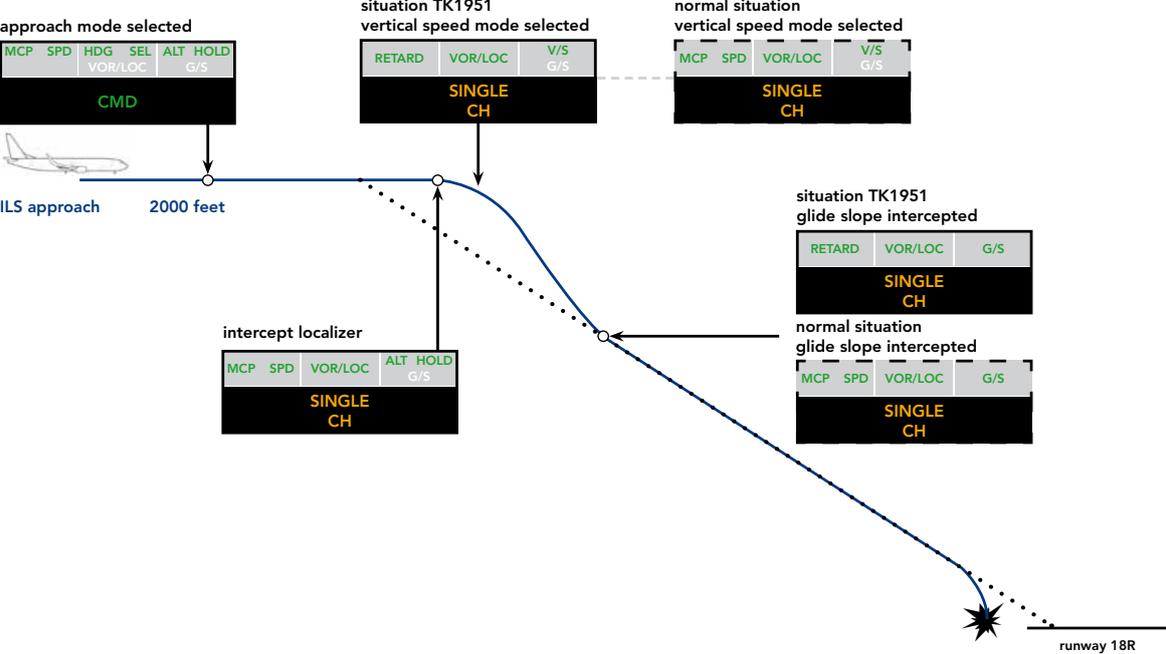
Illustration 20: flight mode annunciations during the approach of flight TK1951
