Midair Collision Over Hudson River  
Piper PA-32R-300, N71MC  
and Eurocopter AS350BA, N401LH  
Near Hoboken, New Jersey  
August 8, 2009

**Aircraft Accident Summary Report**

NTSB/AAR-10/05  
PB2010-910405

NTSB/AAR-10/05  
PB2010-910405  
Notation 8146B  
Adopted September 14, 2010

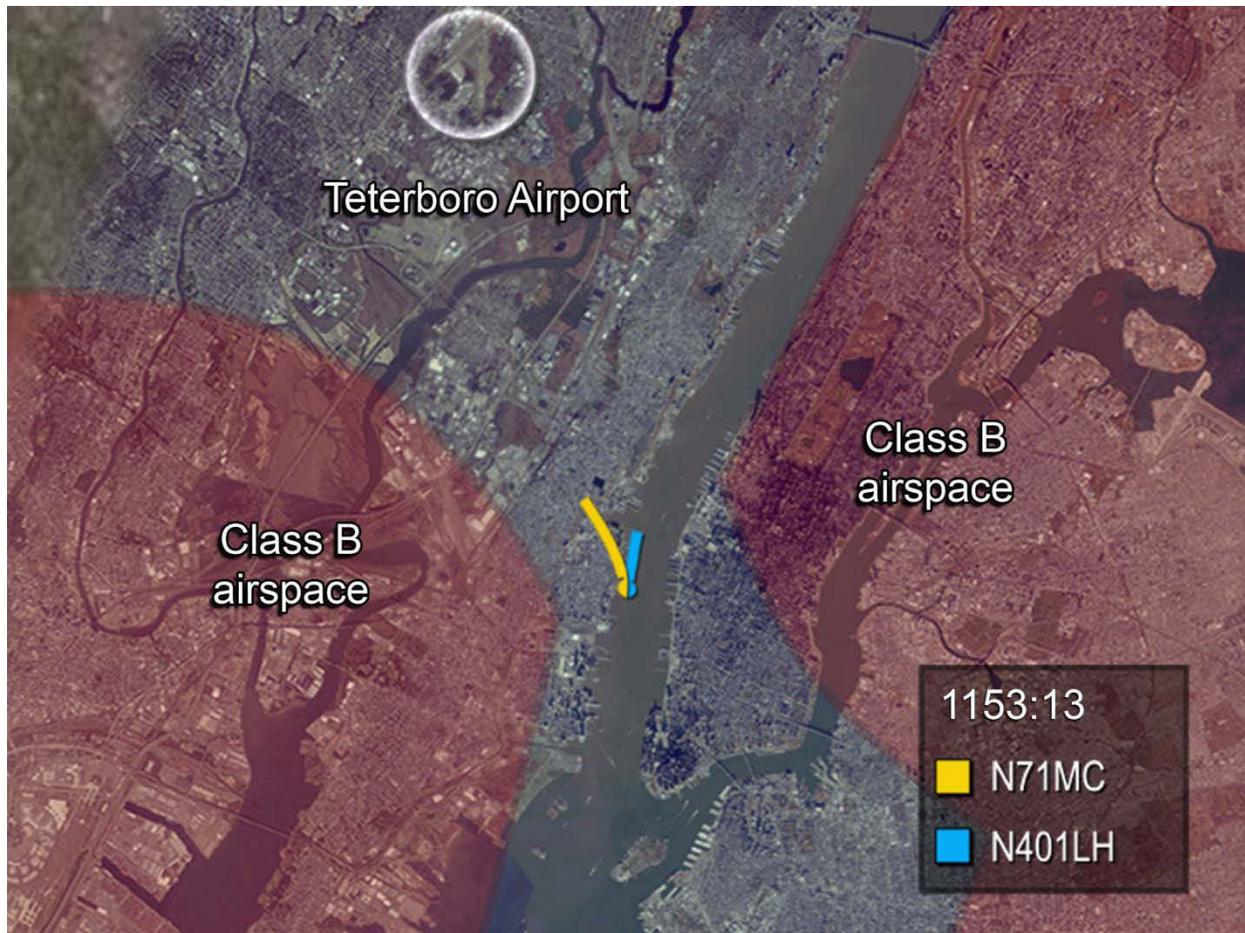
**Figure 2.** Hudson River Class B exclusion area.

Note: The Class B airspace over EWR, shown on the left, extends from 500 to 7,000 feet. The Class B airspace over LaGuardia Airport, shown on the right, extends from the surface to 7,000 feet.
